BUREAU OF SHIPS GROUP TECHNICAL INSPECTION REPORT

⑥ OPERATION CROSSROADS,
USS BANNER (APA60).
TEST BAKER [U].

BUREAU OF SHIPS GROUP
TECHNICAL INSPECTION REPORT

USS BANNER (APA60)

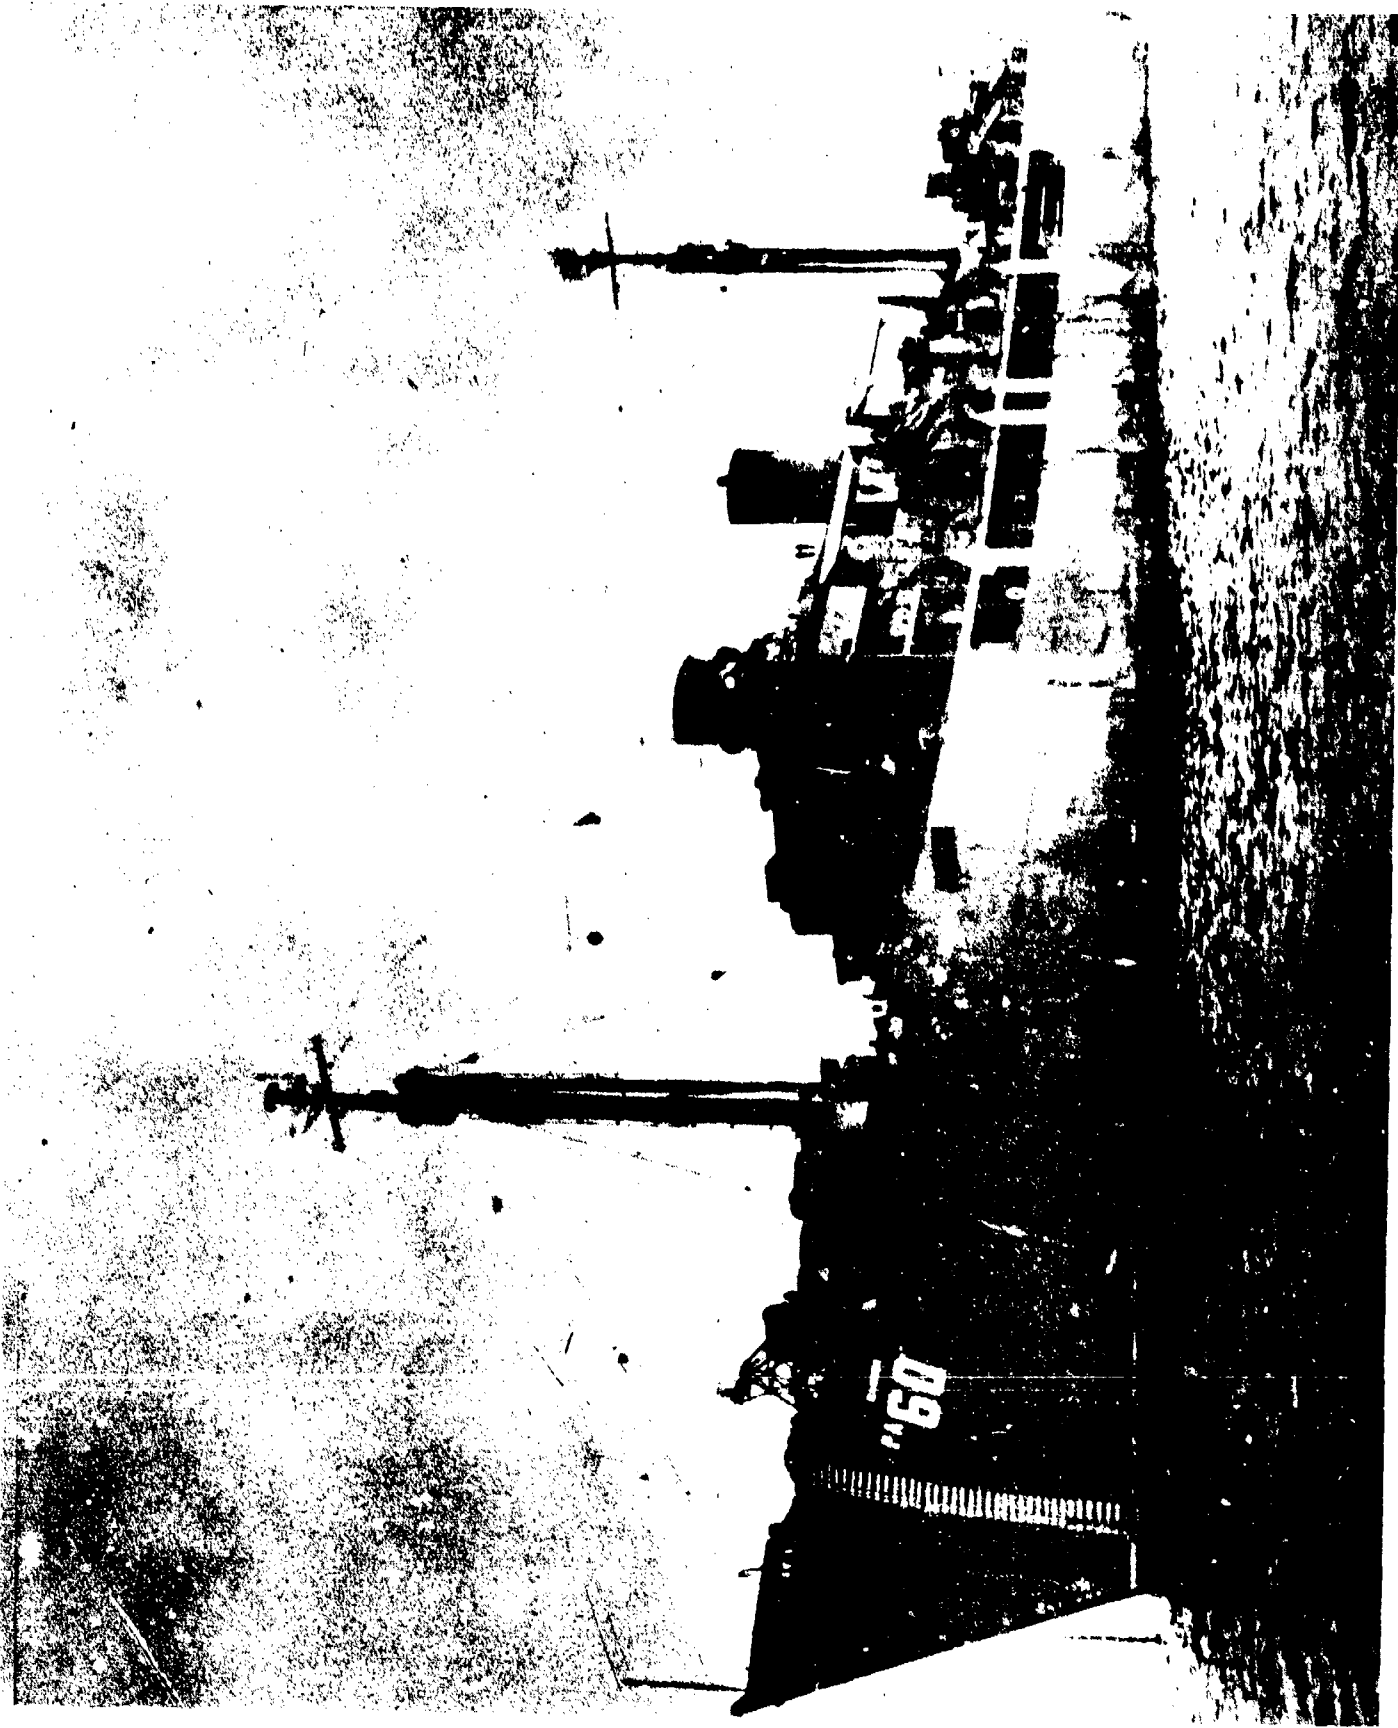
AB-CR-227-243-4. View from off port bow after Test B.
